# HDTV BROADCAST TRAILER

Comprehensive Sales Prospectus & Photo-Detailed Equipment Overview

**Brown Industries purpose-built mobile production trailer • Manufactured 12/2009 • GVWR 13,200 lb**

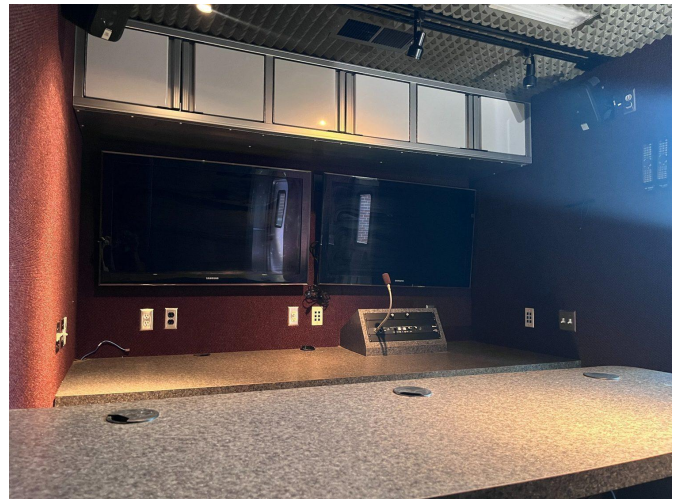
*Current production desk / monitor-wall area after removal of some legacy electronics.*

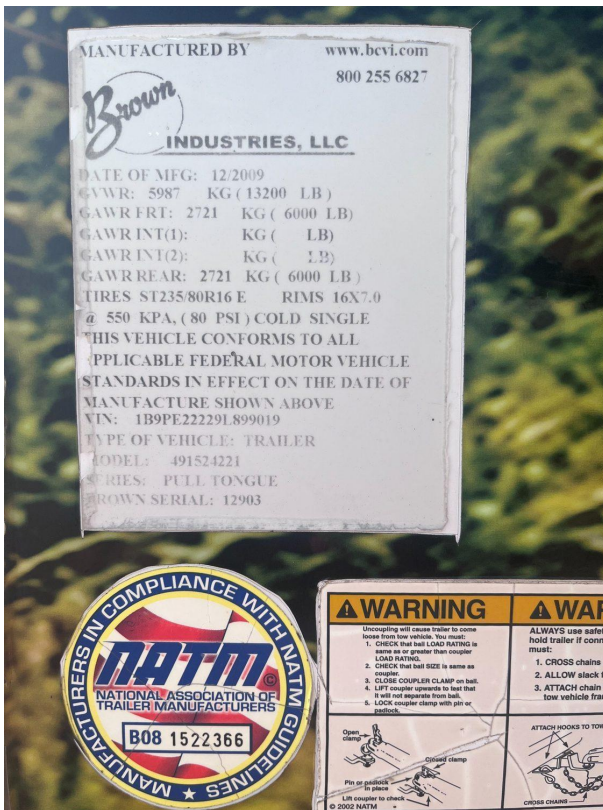
Manufacturer data plate / compliance labels

- Confirms Brown Industries manufacture, 12/2009 build date, 13,200-lb GVWR and 6,000-lb axle ratings.
- VIN and tire/rim specifications are visible on the label.
- NATM compliance decal is also present.

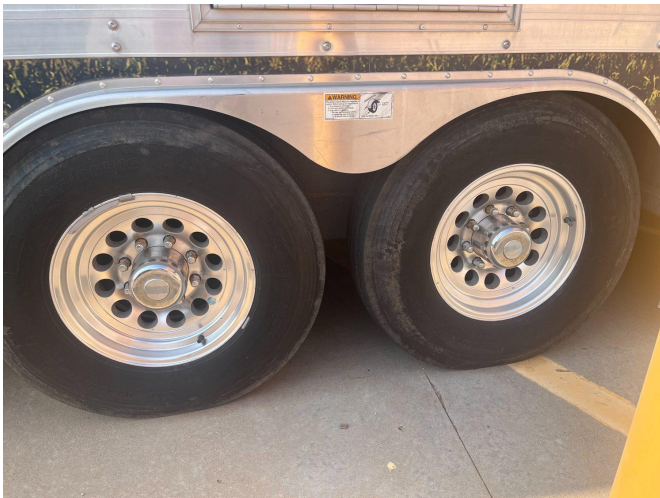
Tandem-axle running gear and aluminum wheels.

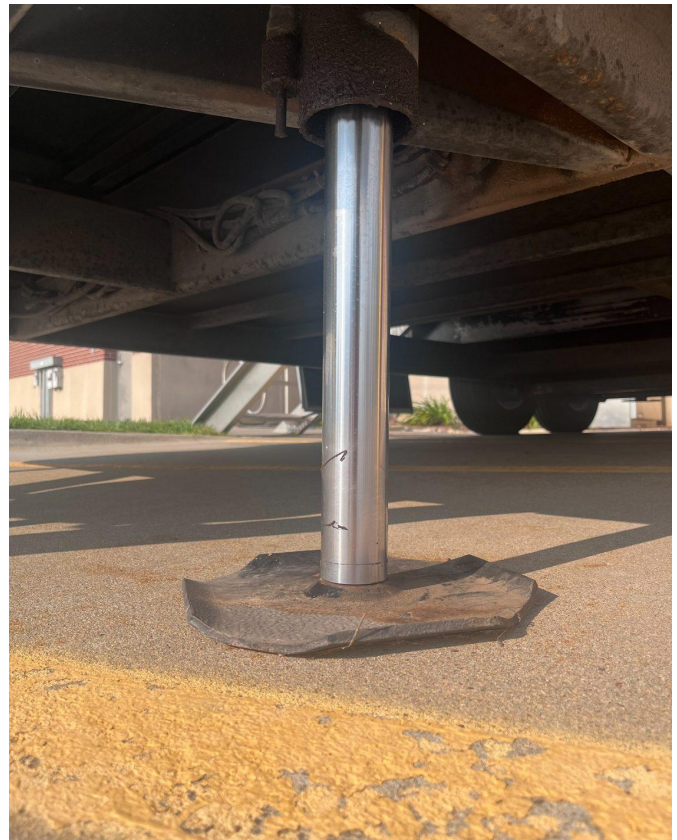
One of the four hydraulic parking/stabilizing feet shown extended.

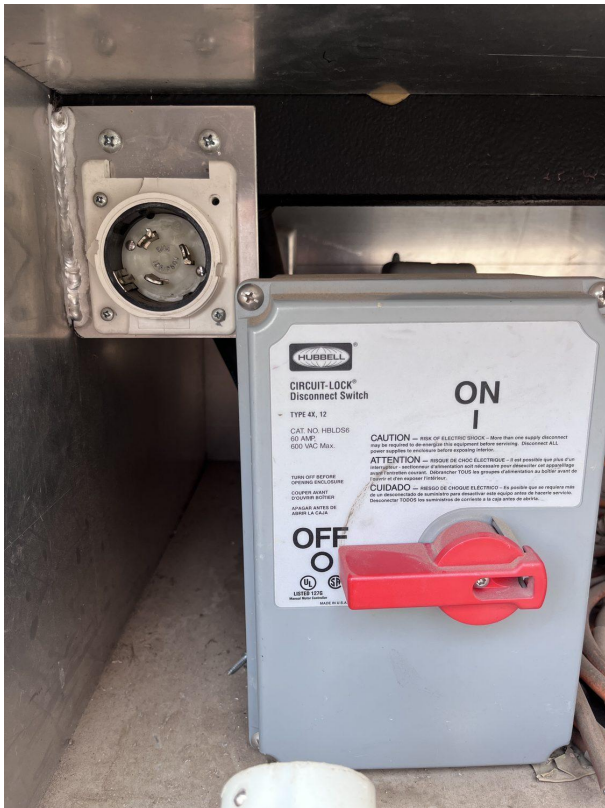
- Twist-lock style shore-power inlet is mounted adjacent to a Hubbell Circuit-Lock disconnect.
- Hubbell enclosure label: Cat. No. HBLDS6, 60 AMP, 600 VAC max. This is the disconnect rating, not a guarantee of actual continuous service capacity.

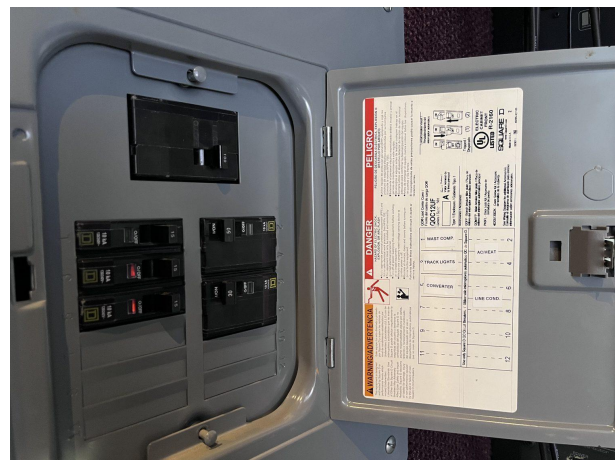
- Square D QO load center with 100 A main breaker visible.
- Circuit directory identifies MAST COMP., AC/HEAT, TRACK LIGHTS, CONVERTER and LINE COND. circuits.
- Additional spare/unused breaker spaces remain.

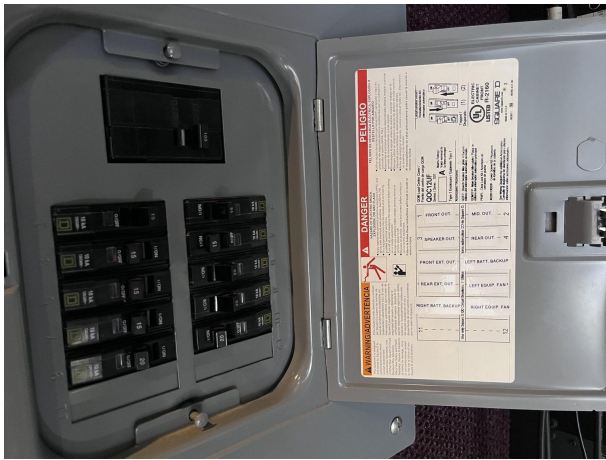
- Second Square D QO load center with 100 A main breaker visible.
- Circuit directory identifies FRONT OUT., MID OUT., SPEAKER OUT., REAR OUT., FRONT EXT. OUT., REAR EXT. OUT., LEFT/RIGHT BATT. BACKUP and LEFT/RIGHT EQUIP. FAN circuits.
- The labeling demonstrates that the trailer was built with dedicated production, exterior and equipment-cooling circuits.

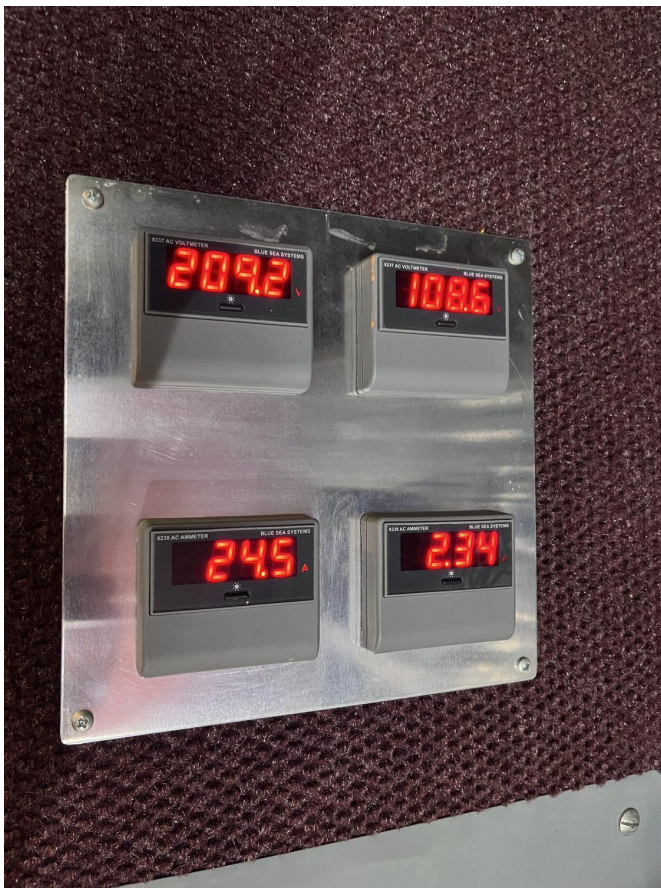
Blue Sea Systems digital AC voltmeter/ammeter panel; energized readings are visible in the photo.

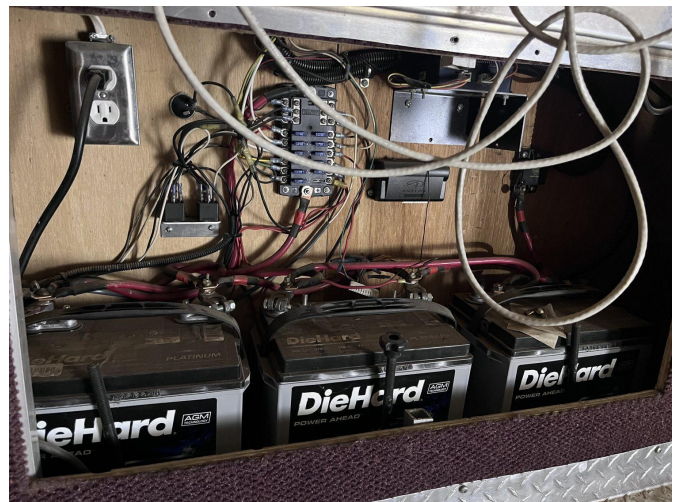
Three DieHard batteries are visible in the lower electrical/utility area; that power the internal task lights and power the hydraulic jacks. Exact battery function and condition should be tested.

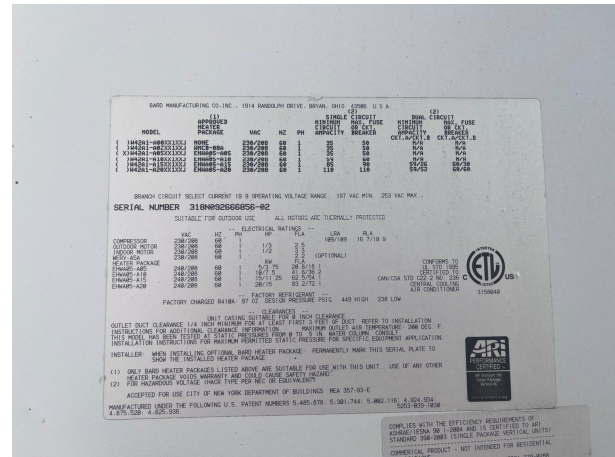
- Bard Manufacturing W42A1-series single-package vertical unit (model-family label visible).
- Electrical rating shown: 230/208 VAC, 60 Hz, single phase.
- Operating voltage range shown: 197–253 VAC.
- Factory refrigerant: R-410A, 97 oz.
- Serial number shown: 318N092665856-02.
- HVAC operation, compressor condition and heat package configuration should be verified by a qualified technician.

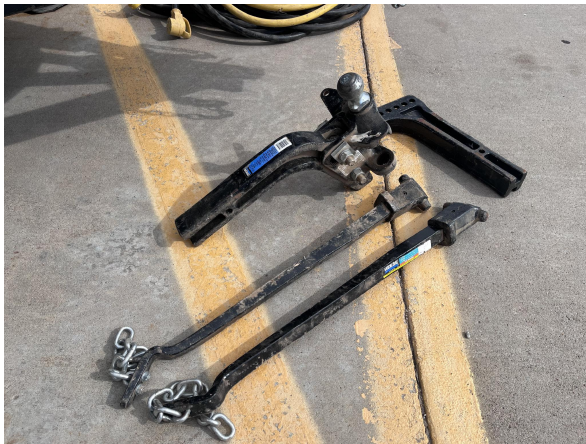
*Reese Titan heavy-duty trunnion-bar weight-distribution setup available as an optional sale accessory.*

- Heavy-duty Reese Titan trunnion-bar weight-distribution hardware is available as an optional part of the sale.
- The photographed 2-1/2 in hitch bar is labeled Reese Part #54977, with a 17,000 lb weight-distribution trailer rating and 1,700 lb tongue-weight rating.
- Buyer should confirm tow-vehicle receiver compatibility and inspect the hitch head, trunnion bars, chains, pins and adjustment hardware before use.

- ☐ 17. Inspect any negotiated Reese Titan weight-distribution hitch components for correct fit, wear, cracks, deformation, missing pins/chains/hardware and tow-vehicle receiver compatibility.

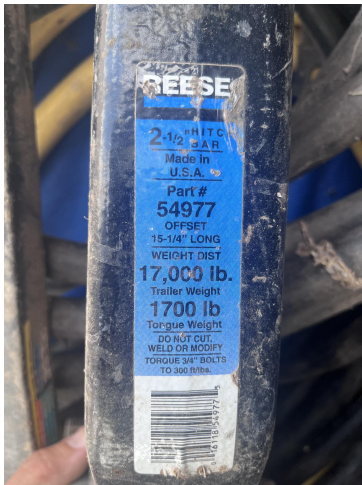
*Reese hitch-bar identification/rating label.*

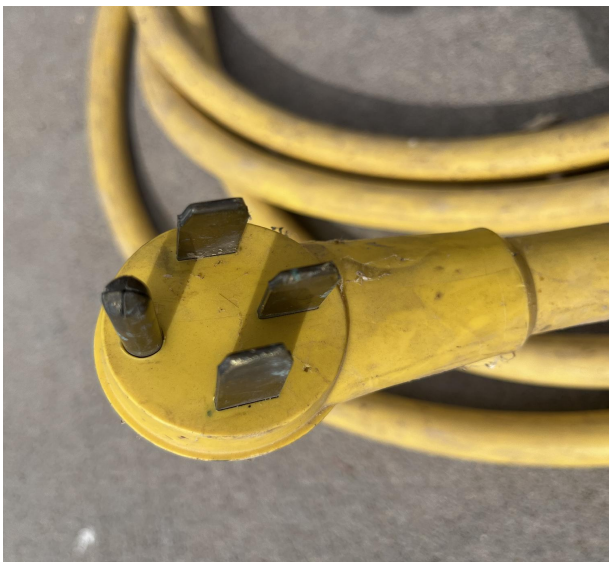
*Yellow shore-power cable plug; two approximately 30-ft yellow cables are available.*

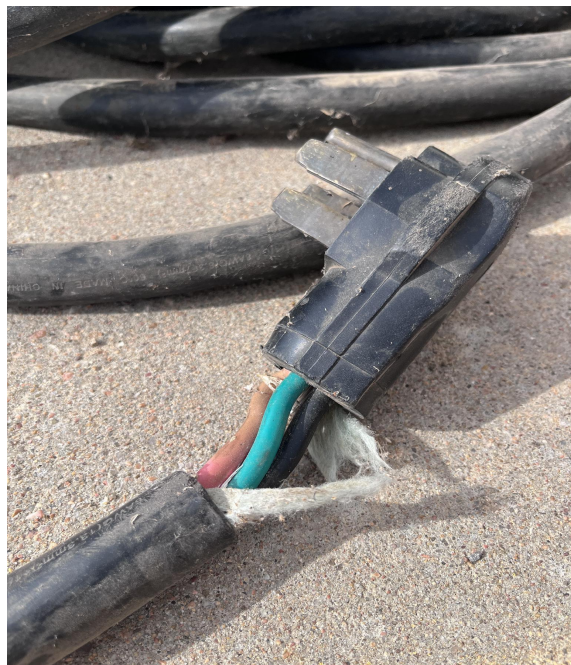
- Approximately 120 ft total of extension cables are available and are reported by the seller to work.
- The extension cables could use maintenance at the plug end: the outer rubber coating/jacket is pulling away from the plug on a photographed cable.
- Two yellow cables that fit the trailer shore-power receptacle are available; each is approximately 30 ft long.
- Power cables are negotiable accessories and should be specifically listed if included in the sale.

*Extension-cable plug end showing the outer jacket/coating pulled away and needing maintenance.*

- ☐ 18. Inspect negotiated shore-power and extension cables before use; repair/replace any damaged jacket or strain relief and verify plug/receptacle condition, grounding and current rating.

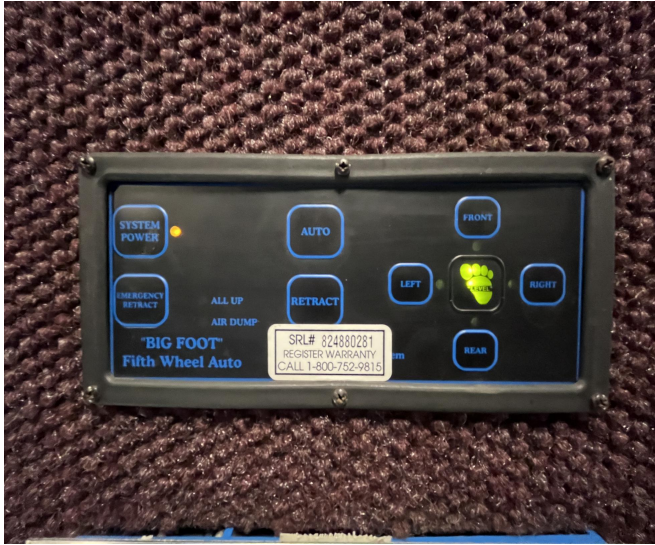
- Four-point hydraulic leveling/stabilization system with dedicated interior electronic control panel.
- Control panel provides SYSTEM POWER, AUTO, RETRACT, EMERGENCY RETRACT, FRONT/REAR/LEFT/RIGHT controls and a level indicator.
- Seller confirms the system is installed and the current control panel is photographed energized.
- Buyer should cycle all four feet and verify automatic/manual leveling, emergency retract, cylinders/hoses, leakage and holding ability.

| Area | Known issue / recommended action |
|---|---|
| Big Foot leveling system | Four-point Big Foot Fifth Wheel Auto hydraulic leveling system is installed; controls are photographed energized. Buyer should verify automatic/manual leveling, emergency retract, cylinders/hoses, leakage and holding ability. |

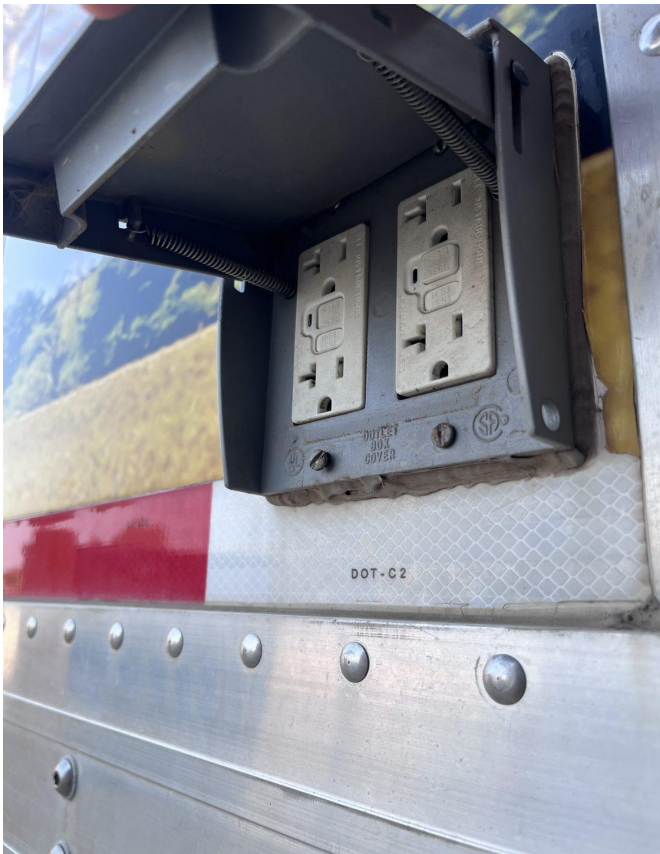
*Exterior weather-protected duplex receptacles / utility outlet panel on all for exterior corners.*

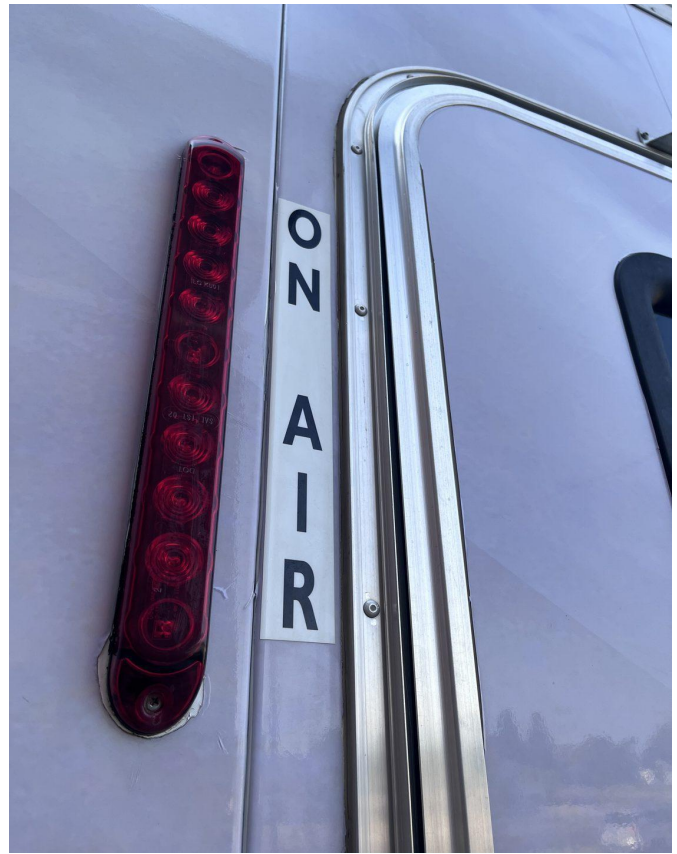
*Exterior red ON AIR indicator lamp adjacent to the personnel-door area.*

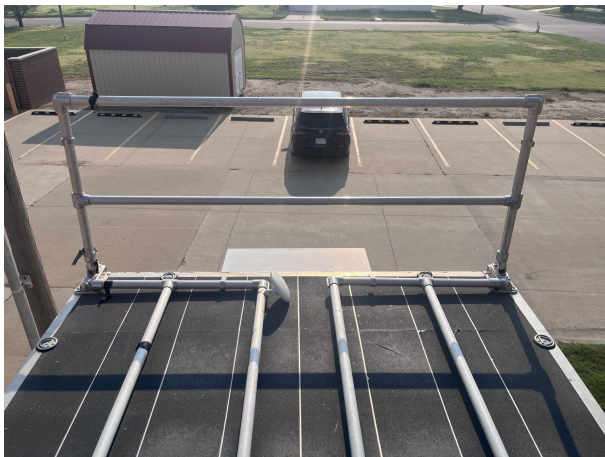
- Pipe-style safety rail section is shown raised at the roof edge.
- Other rail sections fold/stow flat to the roof for travel.
- The roof arrangement creates an elevated working area for antenna, RF, communications or camera-support activities, subject to buyer safety review.

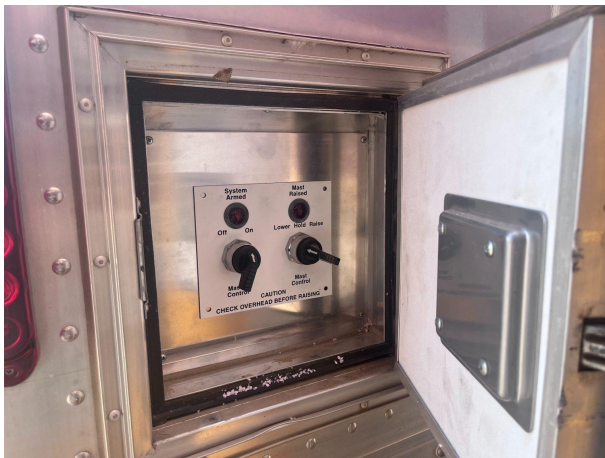
### Protected mast control station

- Weather-protected control panel includes System Armed indicator, Mast Raised indicator and a LOWER / HOLD / RAISE mast control.
- Panel includes the warning "CHECK OVERHEAD BEFORE RAISING."

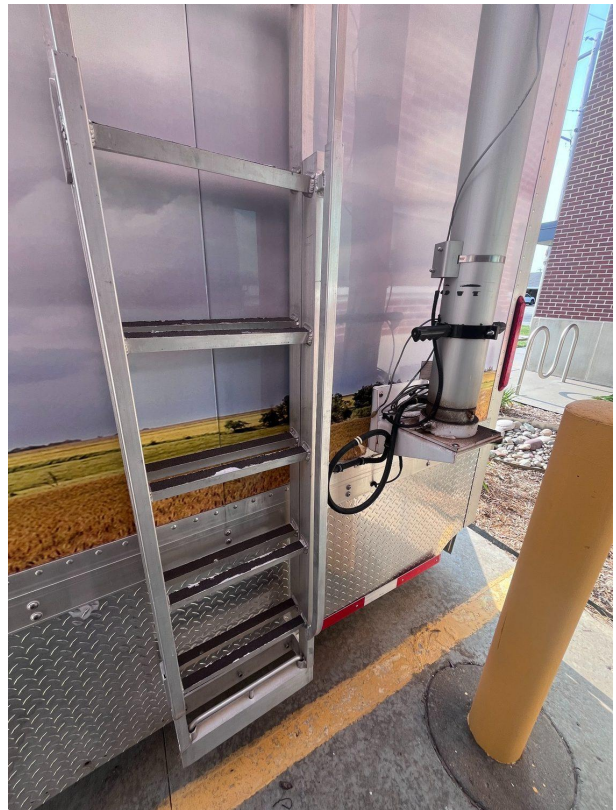
### Exterior mast, ladder & pedestal

- Telescoping mast is mounted on an exterior fabricated pedestal/utility box.
- Permanent aluminum ladder runs alongside the mast.
- Existing mast cabling and cable-management hardware remain.

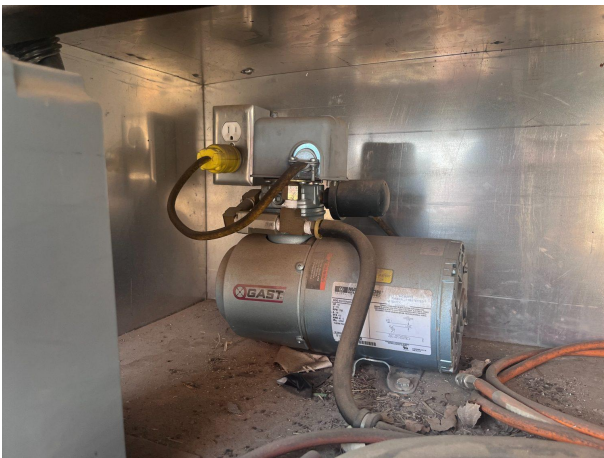
### Gast compressor / pneumatic utility hardware

- Gast compressor and associated hose/valve hardware remain in the exterior utility compartment.
- The compressor is to support the raising of mast/pneumatic system, but the exact operating condition should be confirmed during inspection.

| Area | Known issue / recommended action |
|---|---|
| Mast / compressor | Control hardware and compressor are present; full extension/retraction, air leaks, cable management and safety interlocks should be tested. |

- ☐ 11. Inspect mast base/pedestal corrosion; test Gast compressor and mast under safe overhead-clearance conditions; inspect cabling and interlocks.
- ☐ 12. Open every exterior utility/belly compartment; document missing box, inaccessible box, damaged doors, locks, lighting and water sealing.

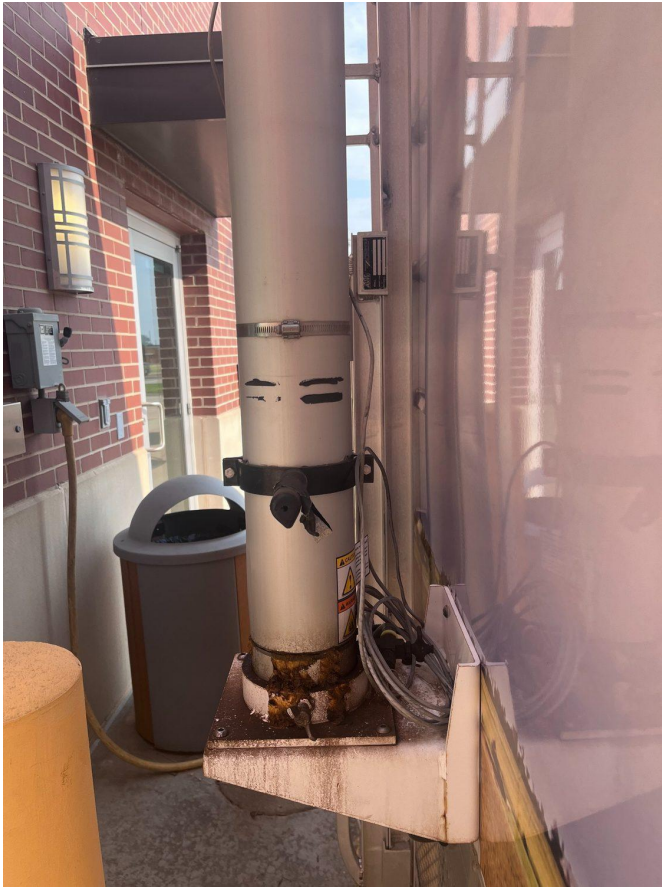
*Mast base / mounting area shows significant corrosion and staining.*

| Area | Known issue / recommended action |
|---|---|
| Mast base / pedestal | Visible rust/corrosion and staining; inspect mounting plate, fasteners, welds, seals and surrounding structure before use. |

Before any use, inspect the roof membrane, seams and penetrations; repair visible torn/loose roof covering; inspect for moisture intrusion; inspect the mast pedestal and base corrosion.

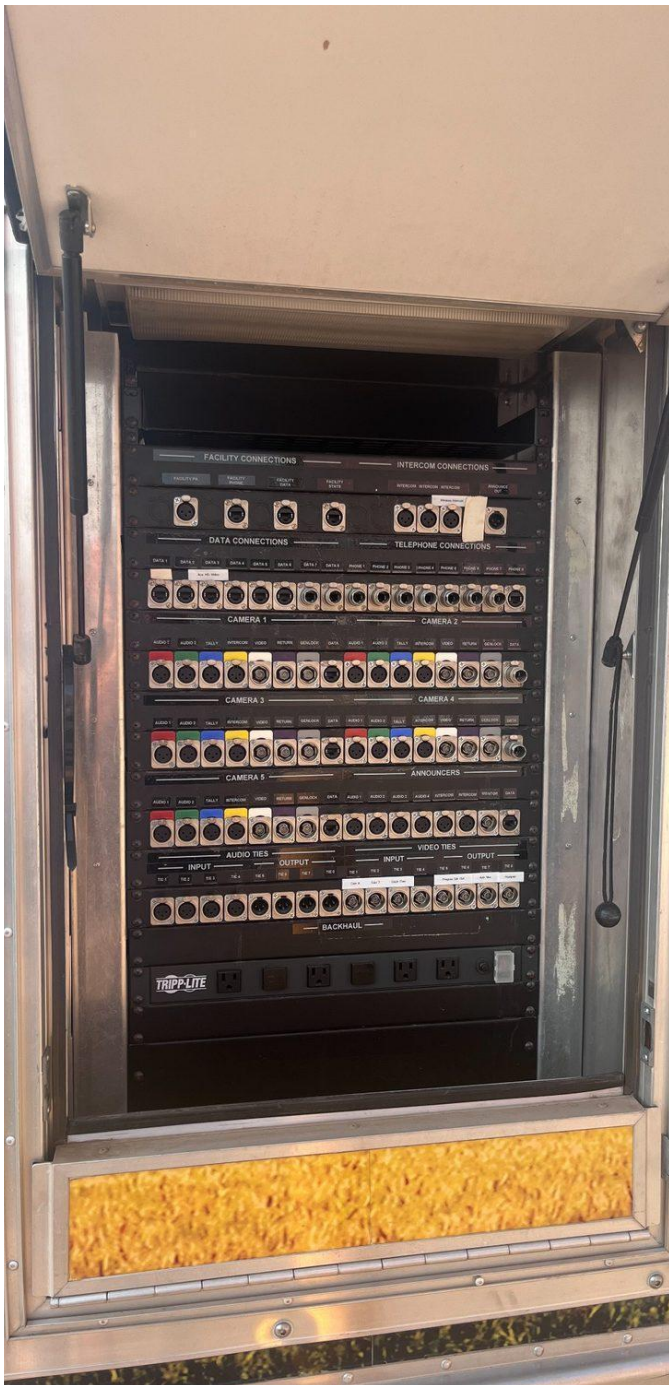
- Large dedicated side access door exposes the broadcast interface rack.
- The bay is lit and arranged for field connection without running temporary cables through personnel doors.
- Fixed connector infrastructure can remain valuable even if legacy processing electronics are removed.

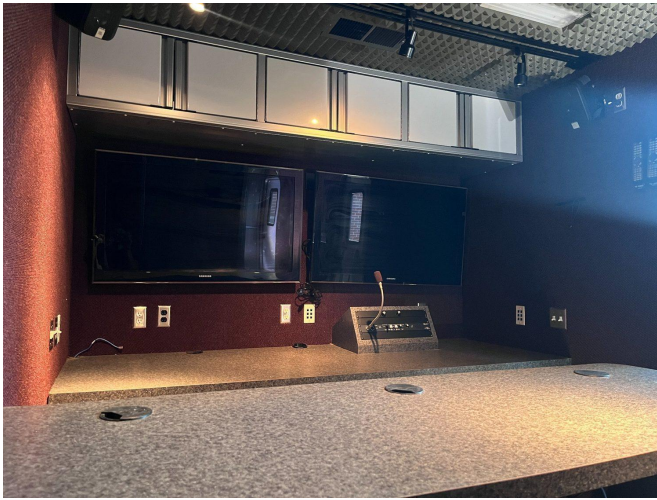
### Current main production work area

- Wide fixed laminate desk with multiple cable grommets and usable operator depth.
- Two large Samsung flat-panel displays remain wall-mounted at the front.
- Overhead aluminum-faced dry erase cabinetry remains installed.
- Front production desk includes a Clear-Com RM-702 2-Channel Remote Station with panel-mic/headset connections, announce/talk/call controls and dual-channel monitoring, plus the existing gooseneck microphone.
- Track lighting, production wall covering and acoustic treatment remain throughout the room.

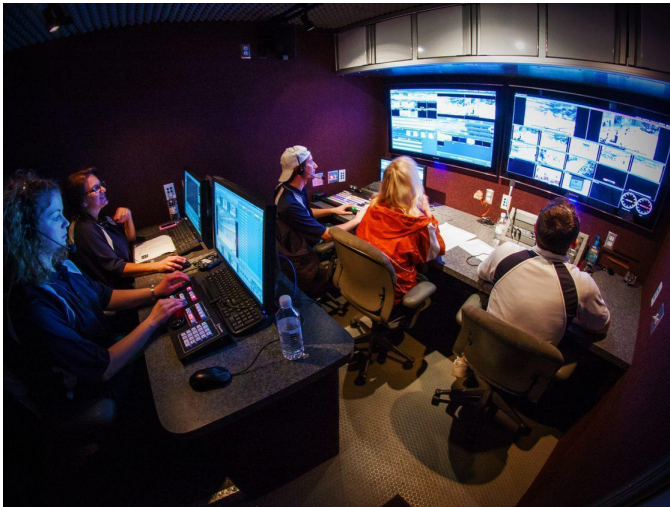
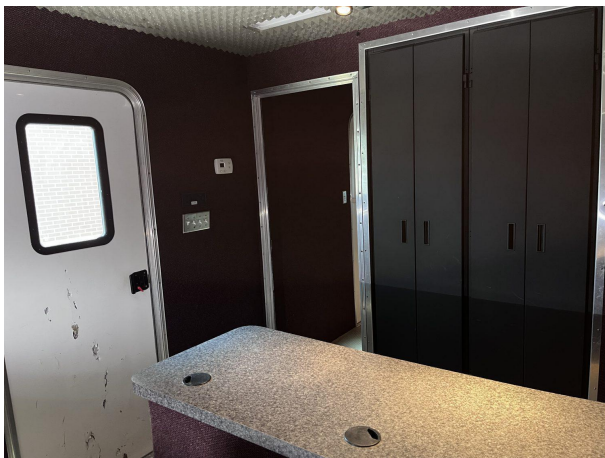
### Rear workstation / storage area

- Secondary fixed work surface provides another operators station.
- Tall enclosed cabinet is backside of equipment racks. Coin-pattern resilient flooring and wall-mounted thermostat/controls are visible.

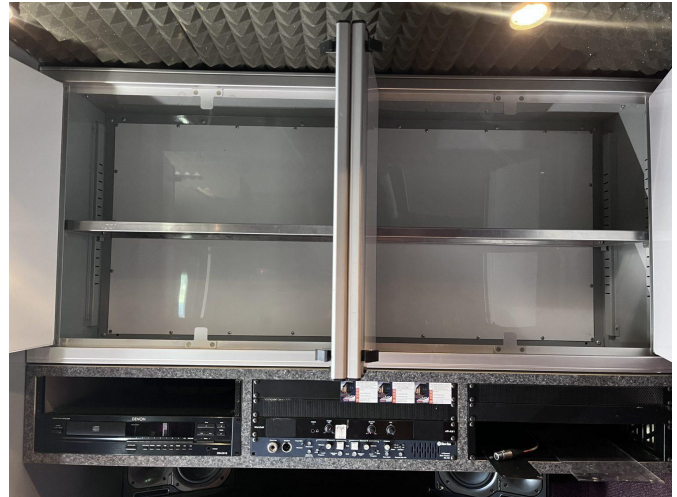
*Audio-position overhead cabinets opened; rack equipment and nearfield speakers remain below.*

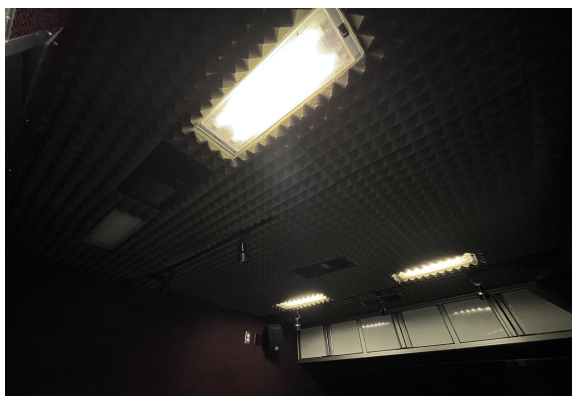
Front room lights shown energized.

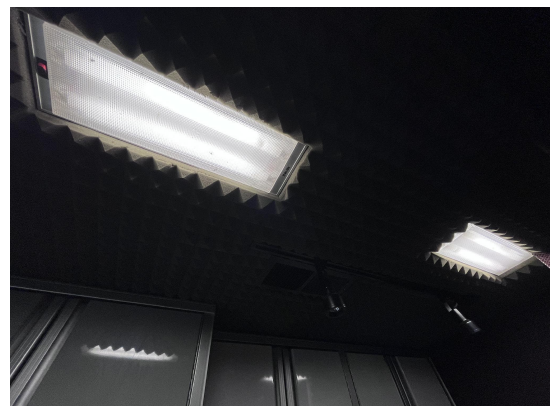
Back Room task lights

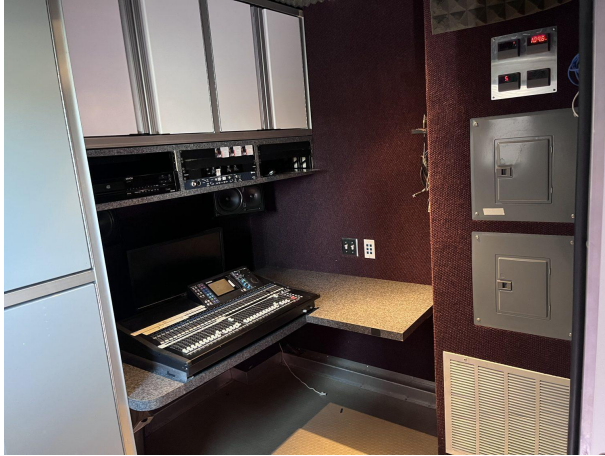
### Audio bay overview

- Dedicated work surface with Yamaha LS9-series digital console mounted at the operator position.
- Two electrical load centers and AC metering are mounted immediately adjacent to the audio bay.
- Overhead cabinets, rack bays, monitoring speakers, display and HVAC return/venting remain.

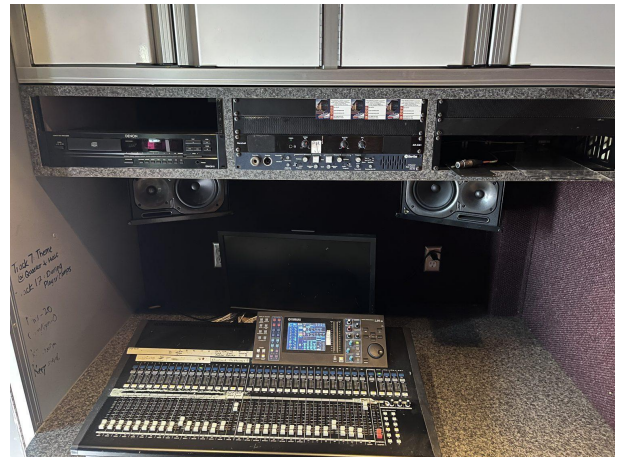
### Yamaha LS9-32 & audio rack equipment

- Yamaha LS9-32 digital mixing console — 32-fader live-production surface visible and powered in the current photo.
- Denon DN-C615 professional CD/MP3 player is visible in the upper left rack bay.
- Marshall AR-AM1 rack audio monitor and Clear-Com MS-702 2-Channel Main Station are installed above the audio board/rear audio position.
- Pair of nearfield monitor speakers and a local flat-panel display remain at the audio position.
- Console and removable electronics are included only if specifically negotiated and documented.

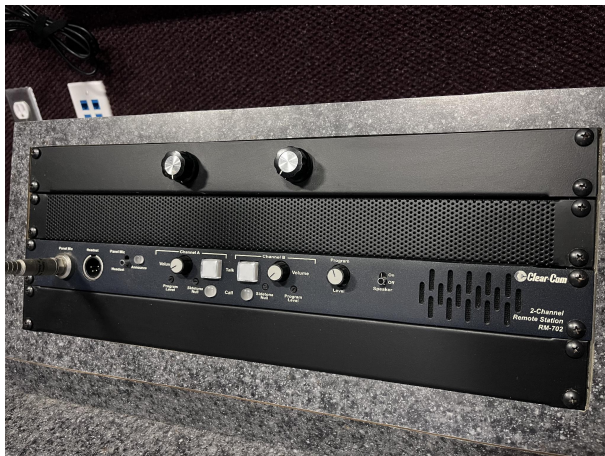
*Clear-Com RM-702 2-Channel Remote Station at the front production desk.*

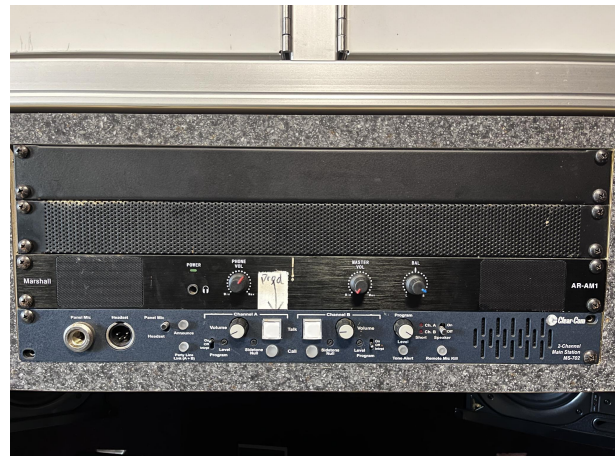
*Clear-Com MS-702 2-Channel Main Station with Marshall AR-AM1 above the audio-board position.*

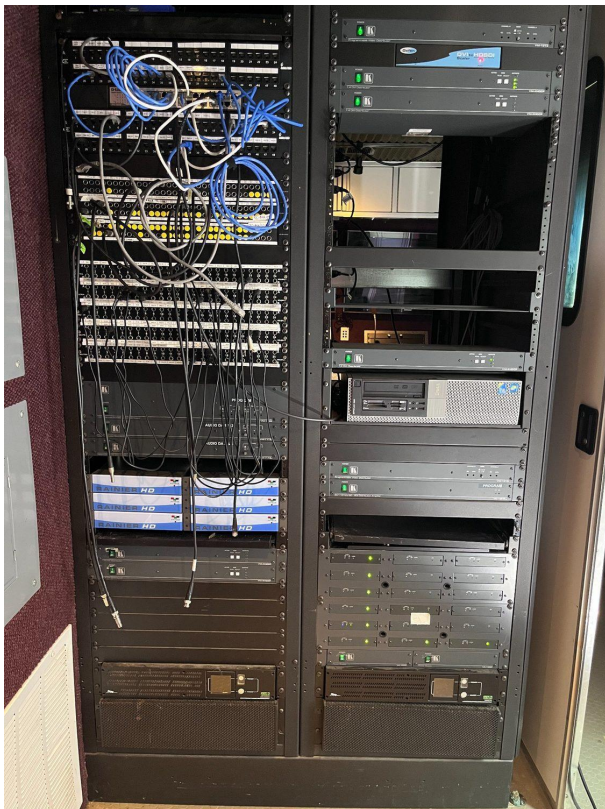
### Primary equipment racks

- Full-height paired rack bays remain substantially wired and partially populated.
- Visible equipment includes patching, multiview, video distribution, computer hardware, modular SDI distribution and larger utility/power chassis.
- Open rack positions provide room for modernization.
- Rack-mounted UPS units remain installed; seller reports the UPS units are not functioning and should be treated as non-operational until repaired or replaced.

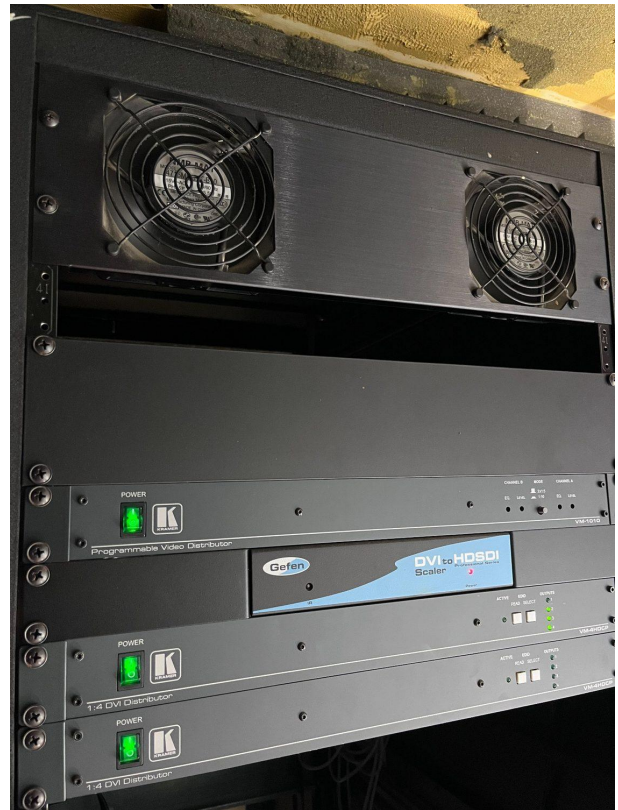
### Kramer / Gefen video-distribution chain

- Kramer VM-1010 programmable video distributor.
- Gefen DVI-to-HDSDI Professional Series scaler.
- Multiple Kramer 1:4 DVI distribution amplifiers.
- Rack-top dual cooling fans.

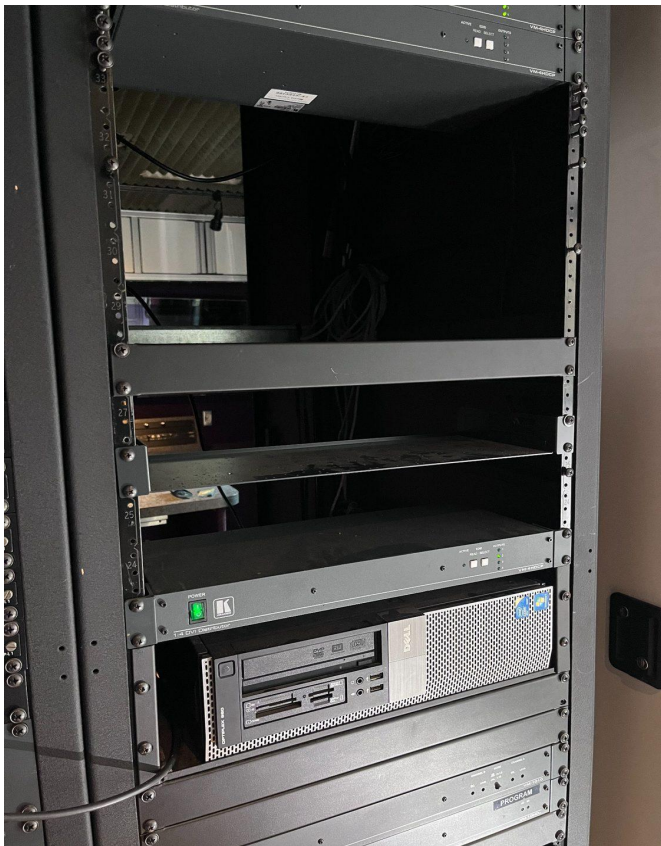
Dell OptiPlex rack-shelf PC, additional Kramer DVI distribution and open rack space.

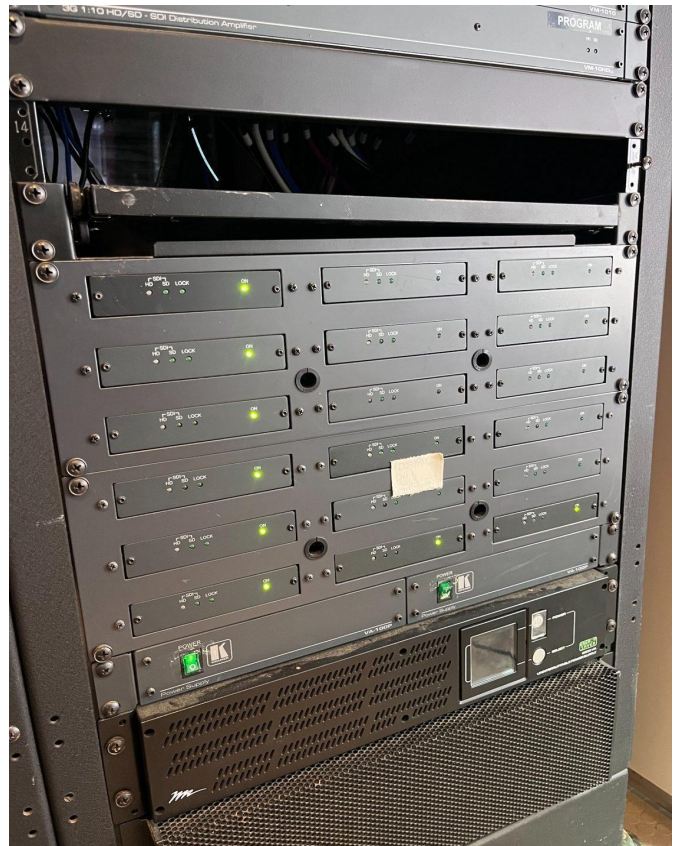
Kramer VM-10HDXL 3G 1:10 HD/SD-SDI DA above a multi-module SDI chassis and lower utility/power equipment.

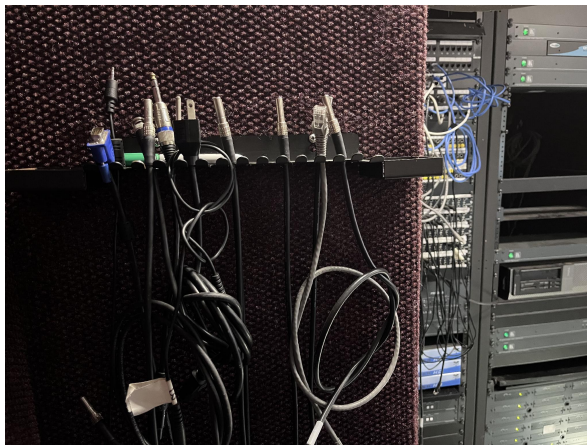
*Wall-mounted patch-cable and adapter storage rack adjacent to the technical equipment racks.*

- Dedicated wall-mounted rack/hanger stores commonly used patch leads and adapters near the equipment racks.
- Visible stored connections include BNC/coax, Ethernet/RJ45, VGA-style and other legacy production/interface leads.
- Useful fixed accessory storage for continued production or a modern retrofit, with individual cable condition/function to be verified.

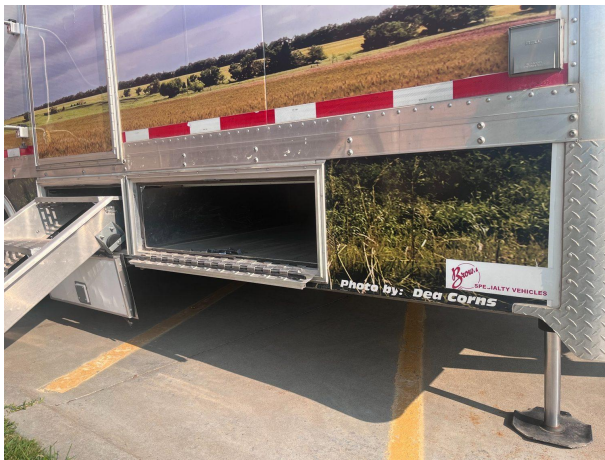
## Large lower storage compartment

- Long lower compartment provides substantial pass-through/utility storage volume.
- Interior shows normal scratches, dirt and service wear.

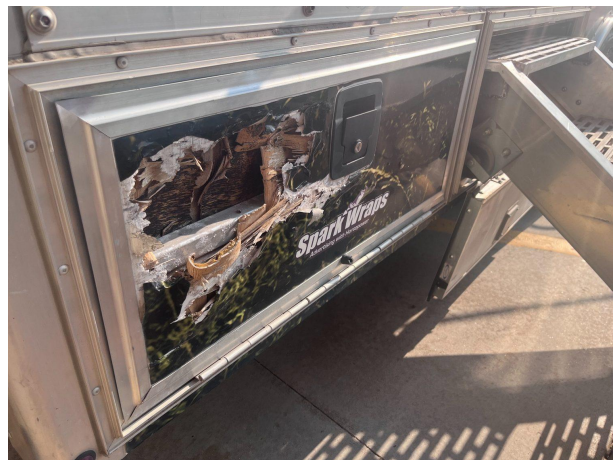
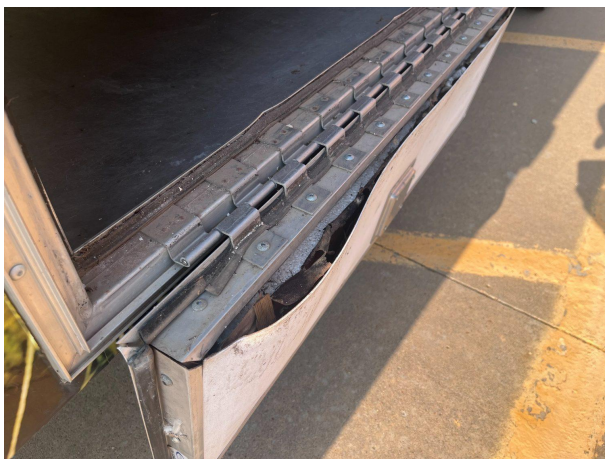
- One lower door/panel has major puncture/delamination damage with wood/substrate exposed.
- This panel should be repaired or fabricated/replaced before weather-tight storage is expected.
- One belly box is completely missing the exterior door.

- Another lower door is visibly bowed and the edge/inner structure shows deterioration/separation.
- Hinge hardware remains, but door sealing and structural condition need repair.

| Area | Known issue / recommended action |
|---|---|
| Belly boxes | Poor condition overall; one reported missing; one locked/inaccessible; several doors/panels damaged or deformed. |

The belly boxes are in poor condition overall. One is reported completely missing; one is locked/inaccessible with no current ability to enter; and multiple photographed doors/panels show deformation, exposed substrate, edge deterioration and/or damage. Budget for fabrication, lock replacement, sealing and repair.

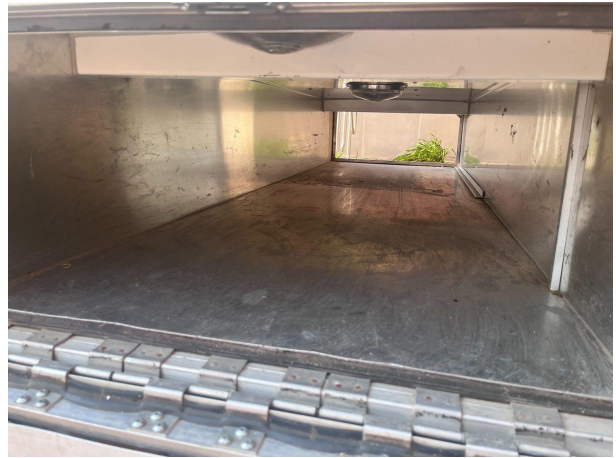
### Interior of lower storage compartment

- Metal-lined storage volume remains usable as a starting point after cleanup/repair.
- Buyer should inspect every compartment for water entry, floor condition, latches and lighting.

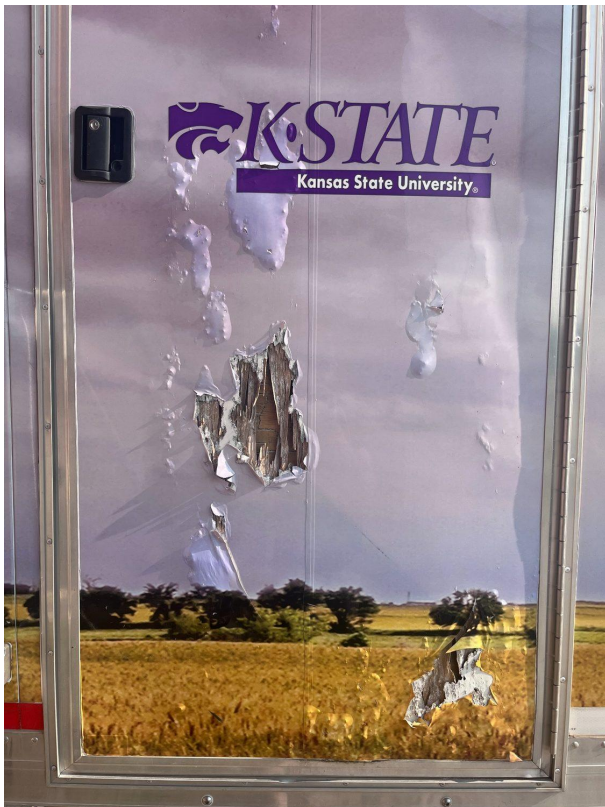
- One personnel-door area shows multiple punctures/tears and exposed substrate beneath the exterior skin/wrap.
- Exterior graphics and body finish also show age, scuffs and peeling in other areas.
- Buyer should inspect door skin, core/substrate and sealing rather than treating the issue as graphics-only.

| Area | Known issue / recommended action |
|---|---|
| Exterior door/body skin | Puncture/delamination damage and exposed substrate visible on at least one personnel-door area; exterior wrap/graphics show age and wear. |

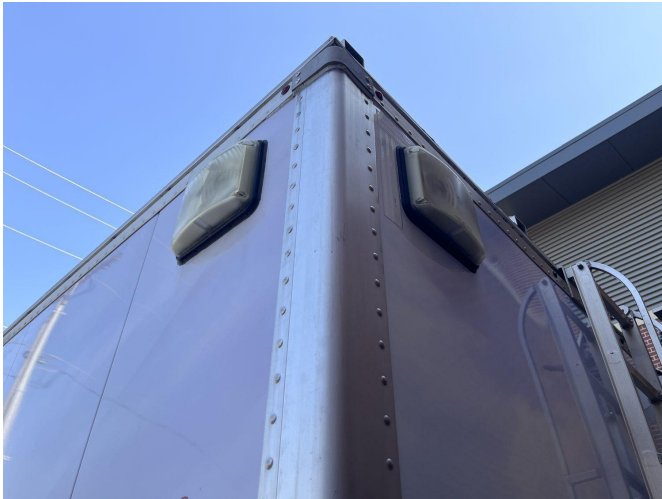
*Strike lights are installed at all four exterior corners; seller reports not all strike lights are currently working.*

| Area | Known issue / recommended action |
|---|---|
| Exterior strike lights | Strike lights are installed at all four corners; seller reports not all are currently working. Test fixtures, switches and wiring. |

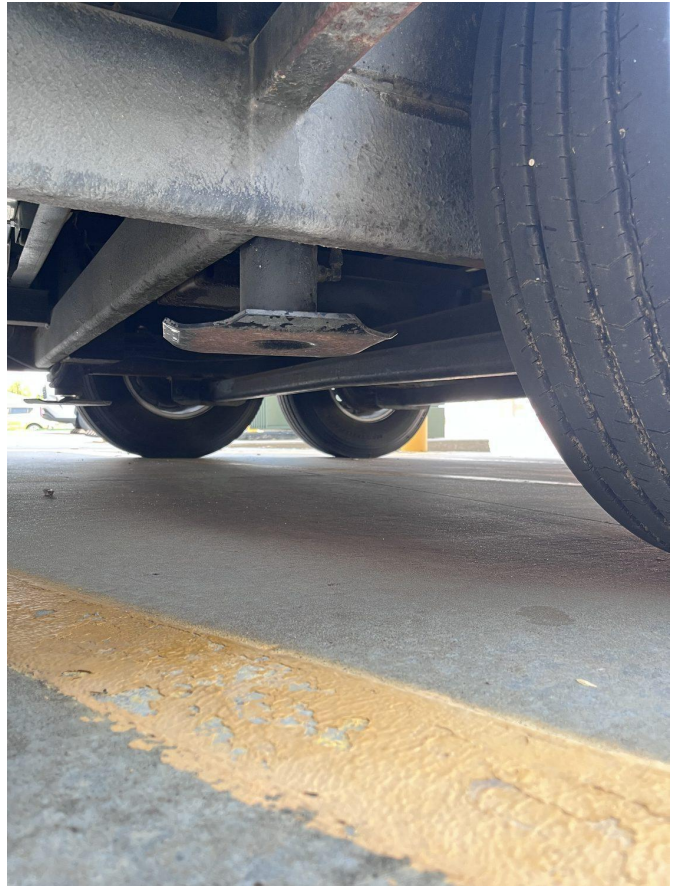
*Underbody/frame view shows back feet for Big Foot Level system*

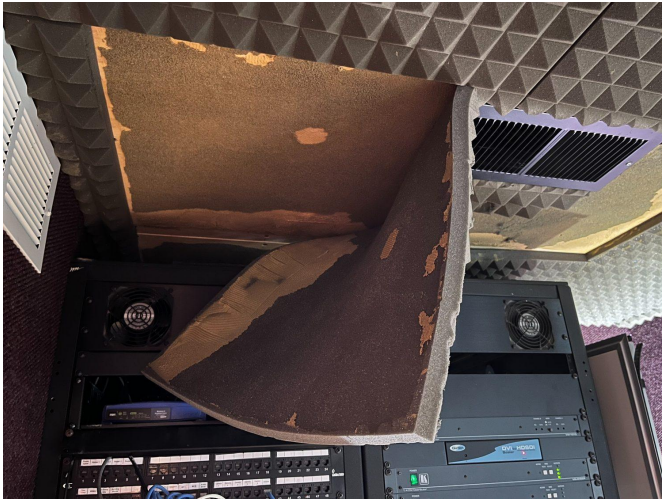
| Area | Known issue / recommended action |
|---|---|
| Interior acoustic foam | Significant peeling/separation, missing sections and a large loose/hanging panel; replacement or re-adhesion with proper surface preparation is needed. |

*Large acoustic foam panel hanging away from the ceiling/wall substrate.*

- ☐ 15. Trace/label any cabling intended for reuse and identify obsolete cable to remove for serviceability/airflow.
- ☐ 16. Inspect interior acoustic foam/substrate and any evidence of moisture before replacing finish materials.

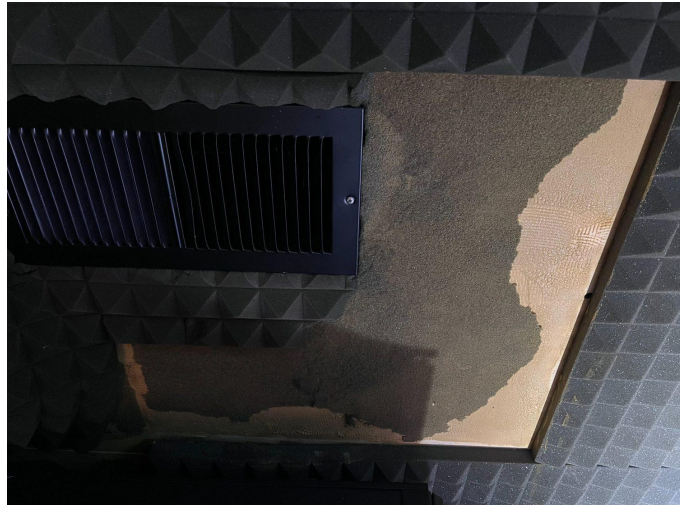
*Large areas of acoustic treatment missing around vent/rack area, exposing adhesive/substrate.*

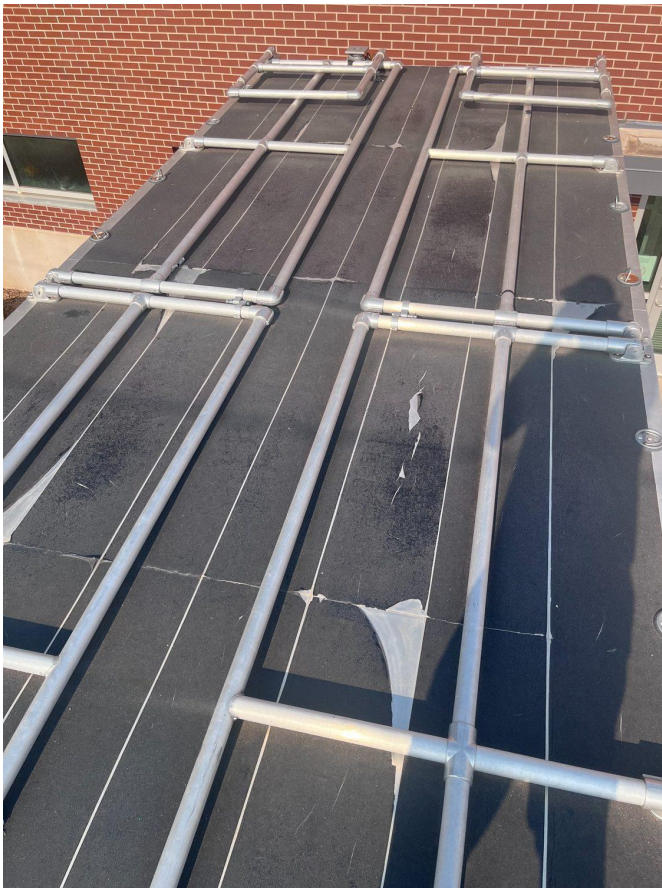
| Area | Known issue / recommended action |
|---|---|
| Roof membrane / covering | Visible tears, cuts, lifted material and previous patching; inspect seams/penetrations and check for underlying moisture intrusion before repair. |

*Visible roof-covering tears/lifted sections.*

- ☐ 9. Inspect roof membrane/covering, seams, penetration seals and any signs of previous water entry; repair visible tears/lifted material.
- ☐ 10. Erect and inspect roof safety railing; verify hinges, pins/locks, fasteners and attachment points.
