# HDTV BROADCAST TRAILER

Comprehensive Sales Prospectus & Photo-Detailed Equipment Overview

**Brown Industries purpose-built mobile production trailer • Manufactured 12/2009 • GVWR 13,200 lb**

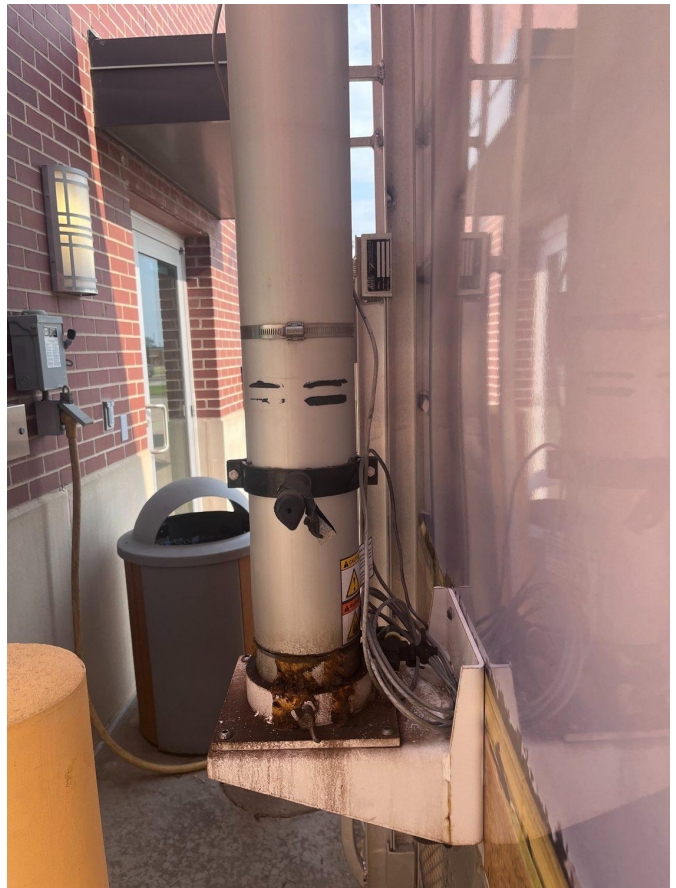
| Area | Known issue / recommended action |
|---|---|
| Mast base / pedestal | Visible rust/corrosion and staining; inspect mounting plate, fasteners, welds, seals and surrounding structure before use. |

*Mast base corrosion and staining.*

Before any use, inspect the roof membrane, seams and penetrations; repair visible torn/loose roof covering; inspect for moisture intrusion; inspect the mast pedestal and base corrosion.

- ☐ 11. Inspect mast base/pedestal corrosion; test Gast compressor and mast under safe overhead-clearance conditions; inspect cabling and interlocks.
- ☐ 12. Open every exterior utility/belly compartment; document missing box, inaccessible box, damaged doors, locks, lighting and water sealing.

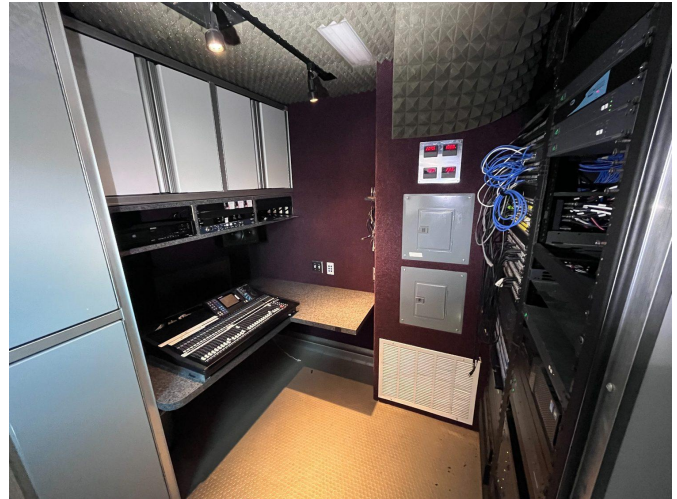
*Current audio/engineering area illustrates the remaining fixed racks, electrical panels and console position.*

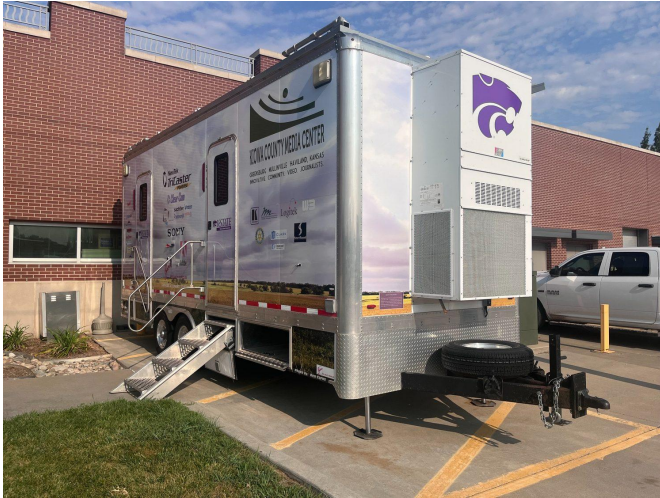
*Current exterior with stabilizers deployed and entry stairs installed.*
